COLORADO CULTURAL RESOURCE SURVEY

Architectural Inventory Form

1. Resource Number: 5DA0670
2. Temporary Resource Number: 766
3. County: Douglas
4. City: Castle Rock
5. Historic Name: Castle Rock Mercantile
6. Current Building Name: B & B Café
7. Building Address: 324 Wilcox Street
8. Owner Name and Address: Lowell D. and Joan A. Bush; 324 Wilcox, Castle Rock, CO 80104

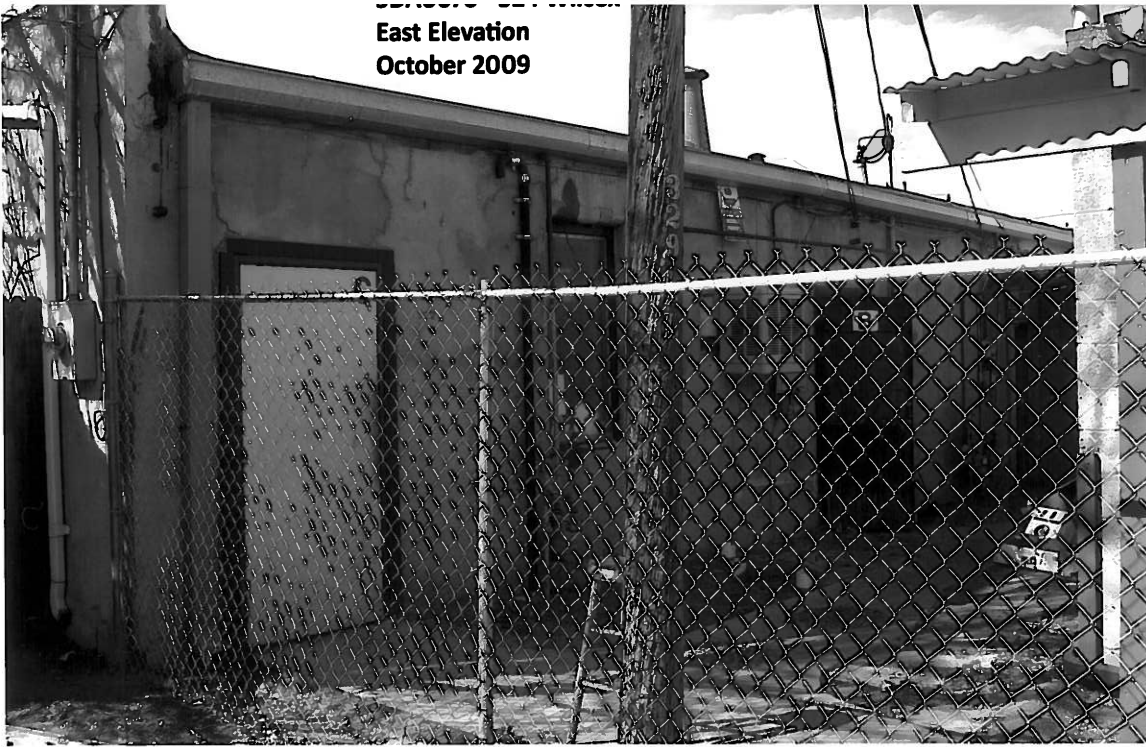
5DA0670 - 324 Wilcox
East Elevation
October 2009

East Elevation: The east elevation is stuccoed and has several openings. There is a flush metal door on the south end with a wood plate glass window adjacent. There is also an opening for a window air-conditioner centered on the elevation. To the north of this entrance there are two more doors.

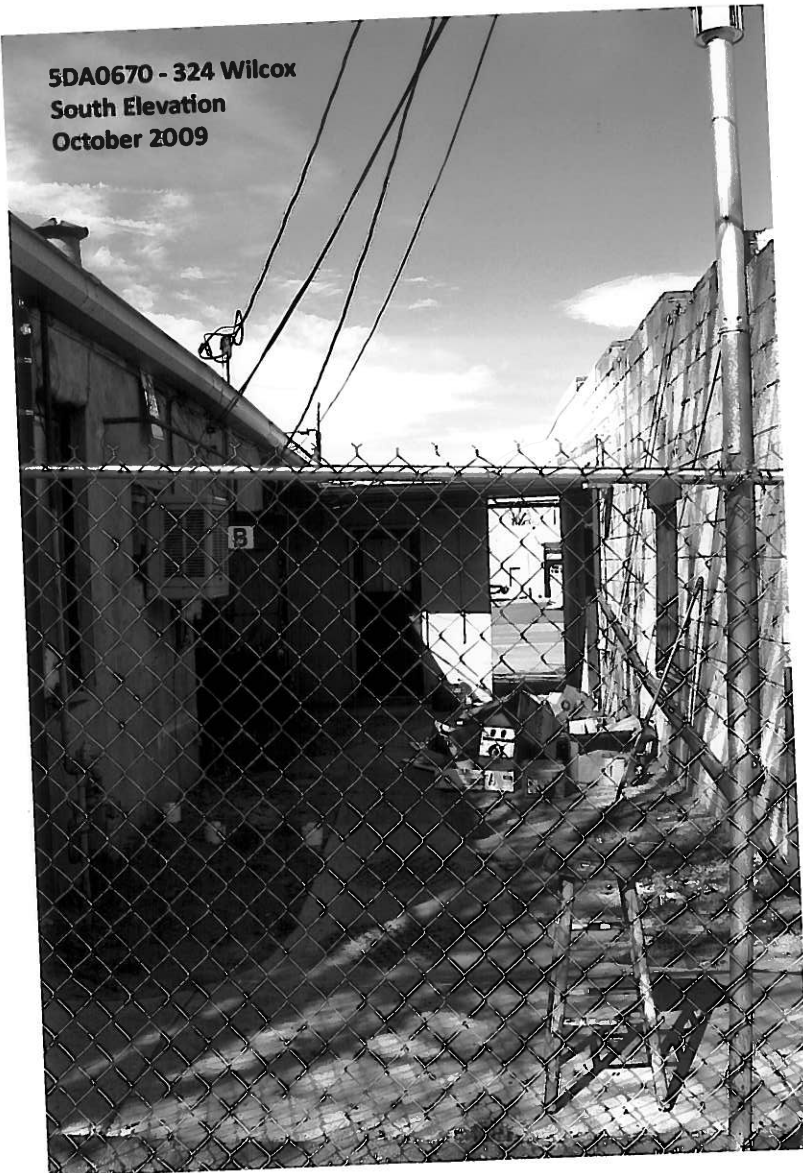
5DA0670 - 324 Wilcox
South Elevation
October 2009

South elevation of addition: This elevation is stuccoed. There is a multi-lite door centered on the elevation.

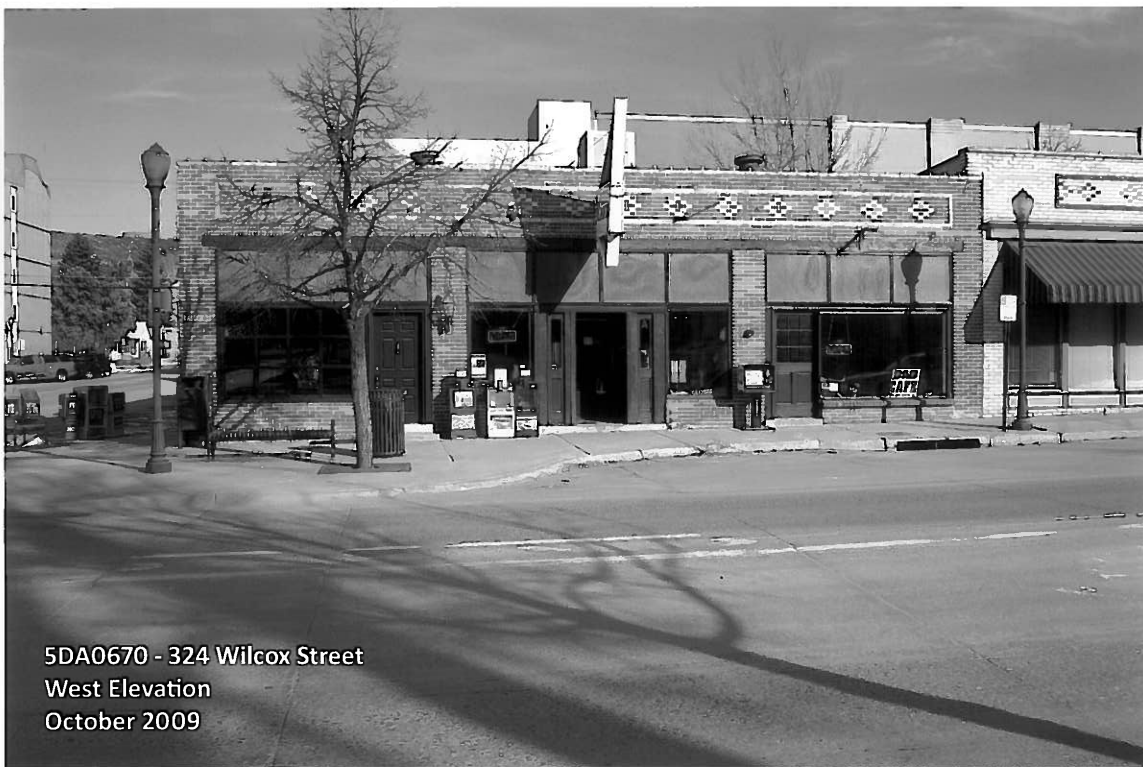
5DA0670 - 324 Wilcox Street
West Elevation
October 2009

Front Façade/West Elevation: The building consists of three bays of which the B & B Café utilizes the middle and south bays. An office utilizes the north bay. The building has the historic red brick surround and red brick columns delineating the separate businesses. There is a course of blond brick at the cornice. The decorative sign band/parapet is outlined in blond brick and infilled with red brick with blond brick repeating pattern. The wood storefront has been modified. The south bay has been partially infilled (between 1935 – 1950) with a non-matching brick and the wood plate glass window above. There is also a non-historic paneled door on the north end of this bay with nine lites. The next bay is the main entrance to the B & B Café. It has a recessed entrance, that has been slightly modified: It no longer angles inward toward the door. There are plate glass windows on either end of the entrance over a historic brick stem wall. The wood storefront in the north bay has been removed and a multilight aluminum window with a door on the south end has been installed. Above in each bay the transom windows still exist, but they have been covered with a metal panel. Above the transom windows is a steel header/belt course supporting the brick parapet and sign band above.

Circa 1996 Windows at the north end of the west elevation were replaced.

The brick stem wall at the south end of the west elevation was rebuilt and lowered several courses.

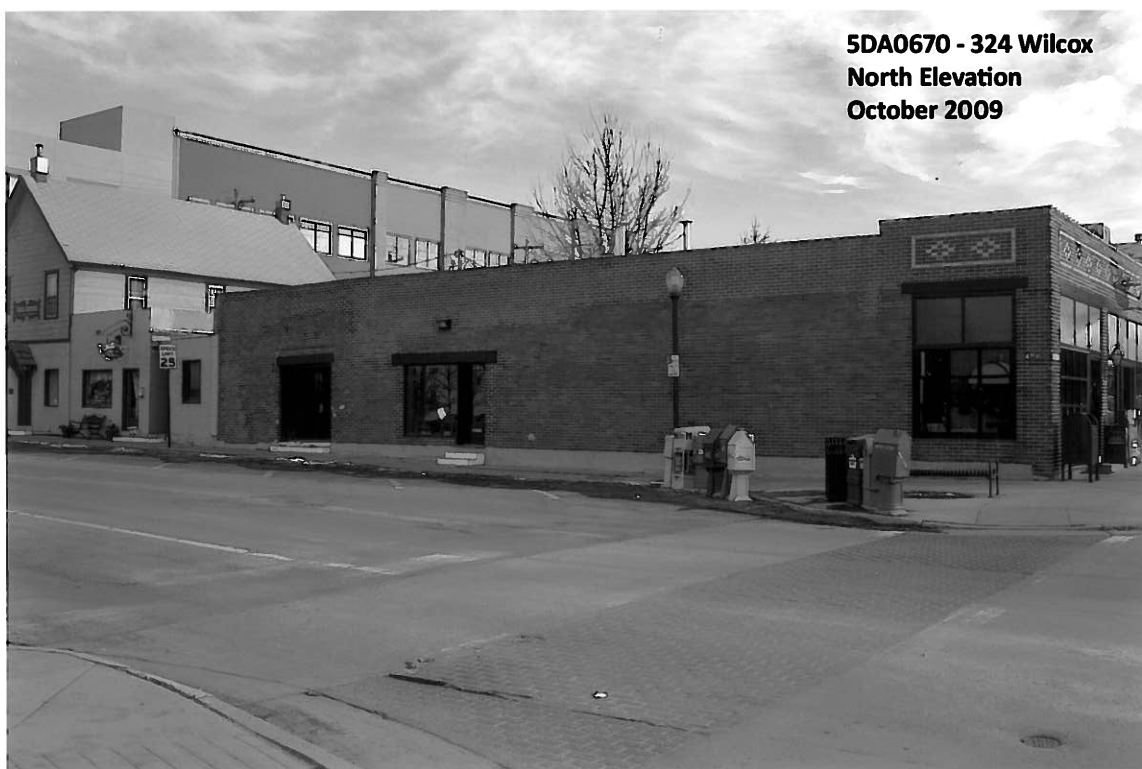
5DA0670 - 324 Wilcox
North Elevation
October 2009

North Elevation: The storefront wraps the corner and extends partway down this elevation. The historic wood storefront has been removed and an aluminum multi-lite storefront window has been installed on the historic brick stem wall with the historic transom windows above. The transom windows have been covered with a metal panel. Near the middle of the elevation is an entrance to another lease space. It is believed that this entrance is non-historic as the header above is concrete instead of the typical steel. Below the lintel is a wood plate glass window with a recessed door to the west. Near the east end of the elevation is yet another entrance. It has a wood lintel over a recessed entrance. The entrance is constructed of wood with an angled plate glass window on the east side. The door is recessed approximately 36" behind the face of the brick. The doors are plate glass. Historically, it appears that the entrance was flush with the brick, as the wood moulding around the brick has block outs for the door latch. There is a non-historic concrete masonry unit stuccoed addition attached to the east end the building. There is a wood plate glass window centered in the elevation.

1950 - 1996 Door opening in the middle of the north elevation was cut into the façade.
